COLORADO CULTURAL RESOURCE SURVEY

Architectural Inventory Form

1. Resource number: 5AH.3678
2. Temporary resource #: N/A
3. County: Arapahoe
4. City: Littleton
5. Historic building name: The Bookhouse
6. Current building name: Colorado Wholesale Dye Corp, et al
7. Building address: 5682 S Cedar St
8. Owner name, address: Han & Bran Llc
5682 S Cedar St
Littleton, CO 80120-1312

Survey of Commercial Modernism in the West Littleton Boulevard Corridor 1950-1980.

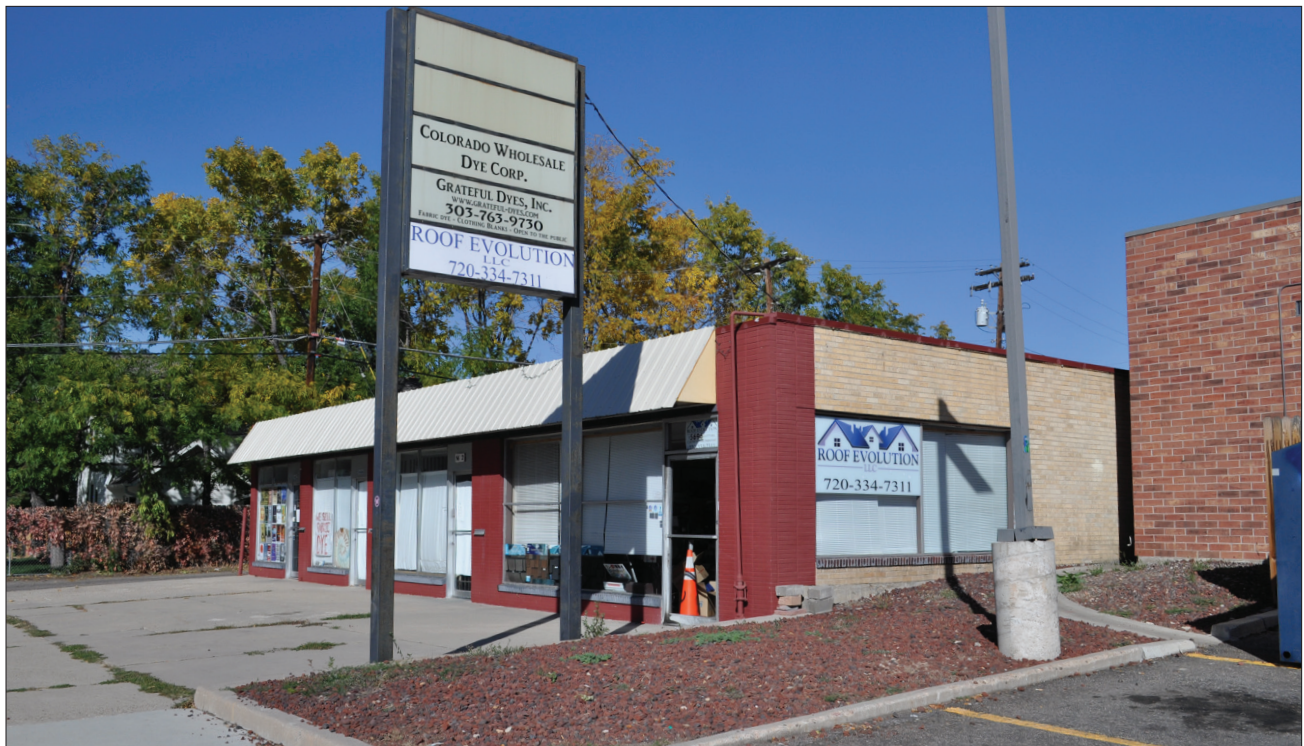
5682 SCS 01.jpg 8

The west wall/facade has an angled mansard-style awning of vertical corrugated metal between the north wall and the south wall. There are four small storefronts divided by panels of stack-bond Norman brick, each with a single metal and glass door and blind or glass transom. North of each door are pairs of windows over very low, angled rowlock sills.

The stack-bond Norman brick continues onto the face of the south wall to a pair of large windows above a rowlock sill. The balance of the wall is masonry of standard and half brick.

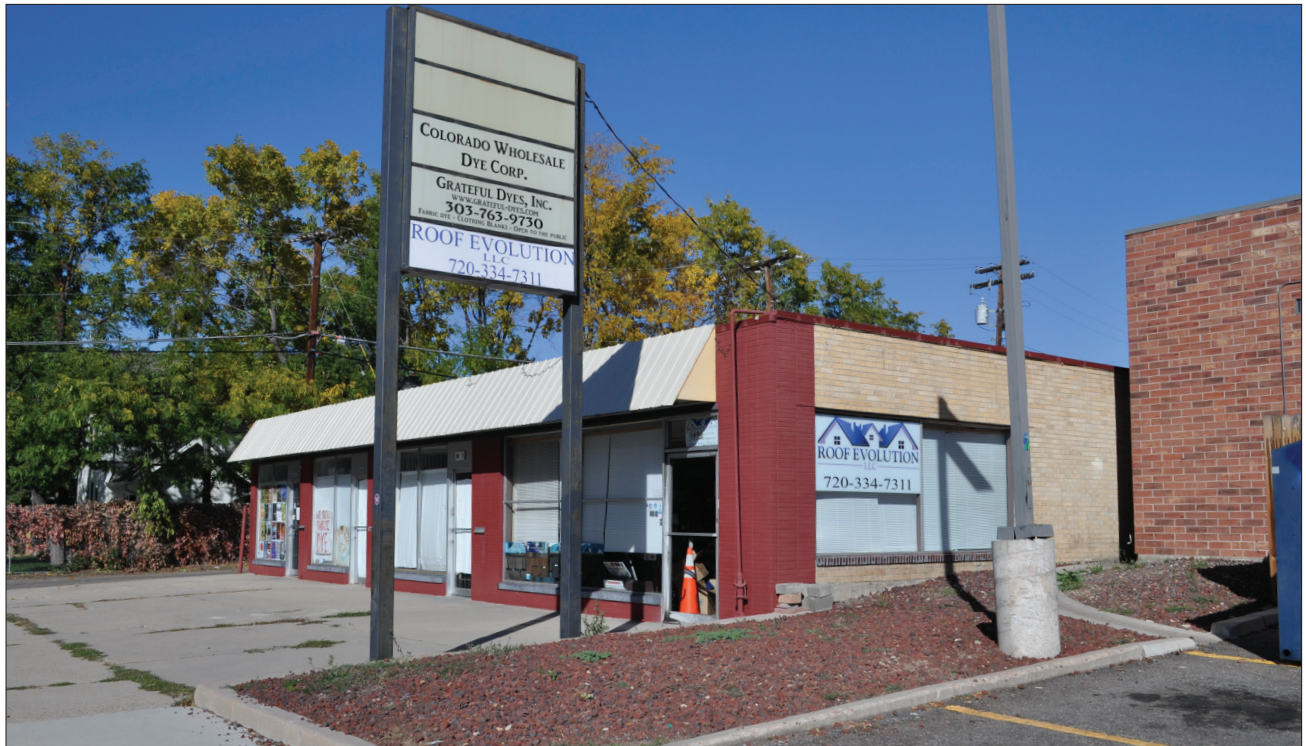
Photo: 5682 WLB 01.jpg
West Wall, facade (left); South Wall (right).
