COLORADO CULTURAL RESOURCE SURVEY

Architectural Inventory Form

- 1. Resource number: 5AH.3680
- 2. Temporary resource #: N/A
- 3. County: Arapahoe
- 4. City: Littleton
- 5. Historic building name: State Motor Vehicle Department Annex
- 6. Current building name: Life Center
- 7. Building address: 5814 S Datura St
- 8. Owner name, address: Mission Hills Baptist Church
620 Southpark Dr
Littleton, CO 80120-5675

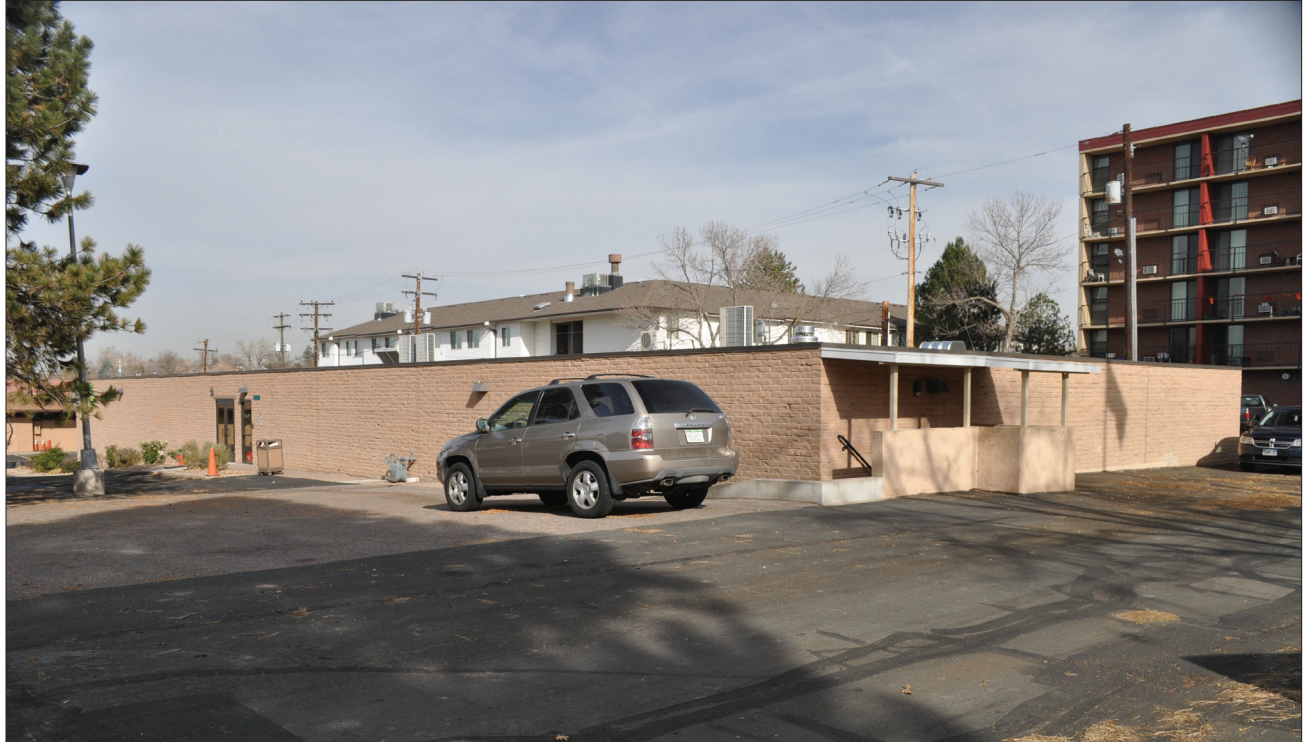
The one-story building has a rectangular footprint and flat roof with narrow flush metal fascia. The material is oversized adobe-style brick masonry with metal and/or glass doors.

The west side/facade is a continuous brick masonry wall with a single and double glass and metal doors immediately adjacent to each other toward the north end of the building. The north side of the building, at the lower grade of the lot, has a raised concrete loading platform with two metal pedestrian and garage doors. On the south side of the building, at the higher grade, a concrete stair descends to a lower-level service entrance, sheltered by a small canopy supported by a series of columns above low stucco wall. The east side of the building is a blind brick masonry wall.

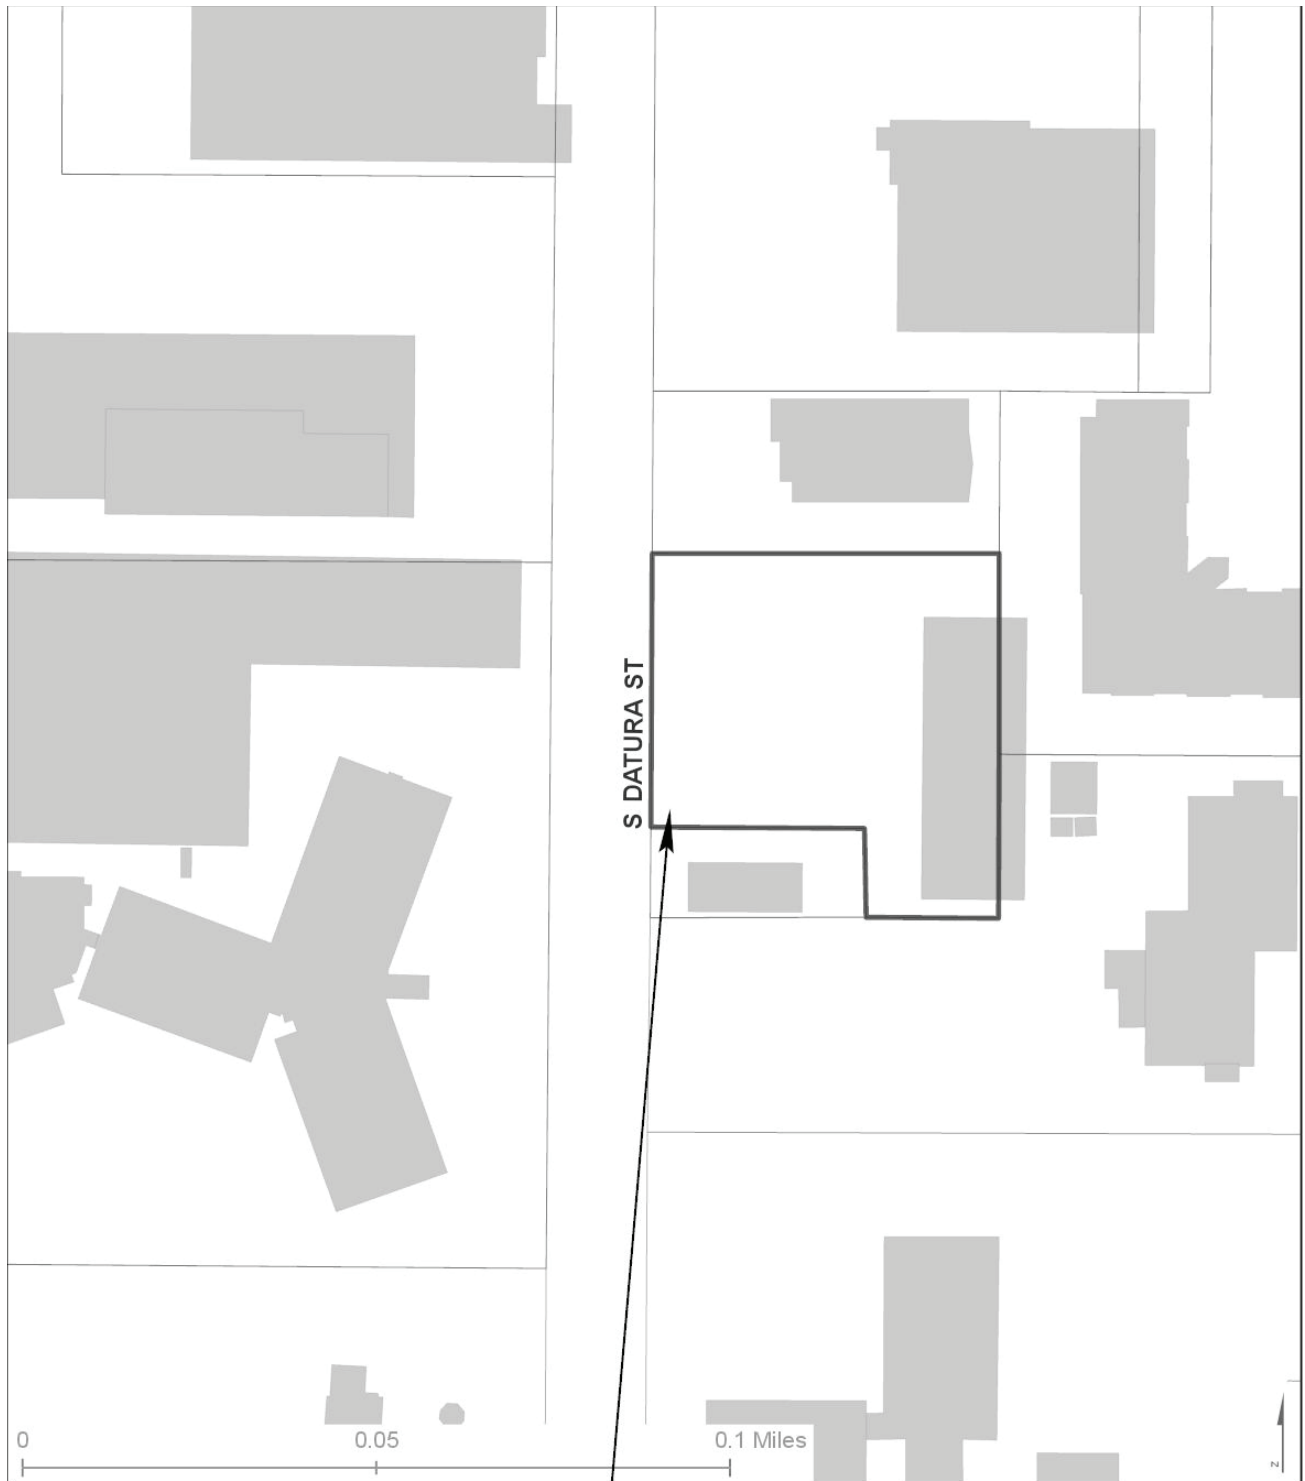
Sketch Map

The former Colorado State Motor Vehicle Department Annex is sited parallel to the street along the east side of a large "L" shaped, sloping lot facing S Datura St.
