COLORADO CULTURAL RESOURCE SURVEY

Architectural Inventory Form

1. Resource number: 5AH.3684
2. Temporary resource #: N/A
3. County: Arapahoe
4. City: Littleton
5. Historic building name: Tammy G's Beauty Bazaar
6. Current building name: Vacant
7. Building address: 5649 S Delaware St
8. Owner name, address: Shirley K Shelton Revocable Trust
PO Box 2463
Parker, CO 80134-1418

Survey of Commercial Modernism in the West Littleton Boulevard Corridor 1950-1980.

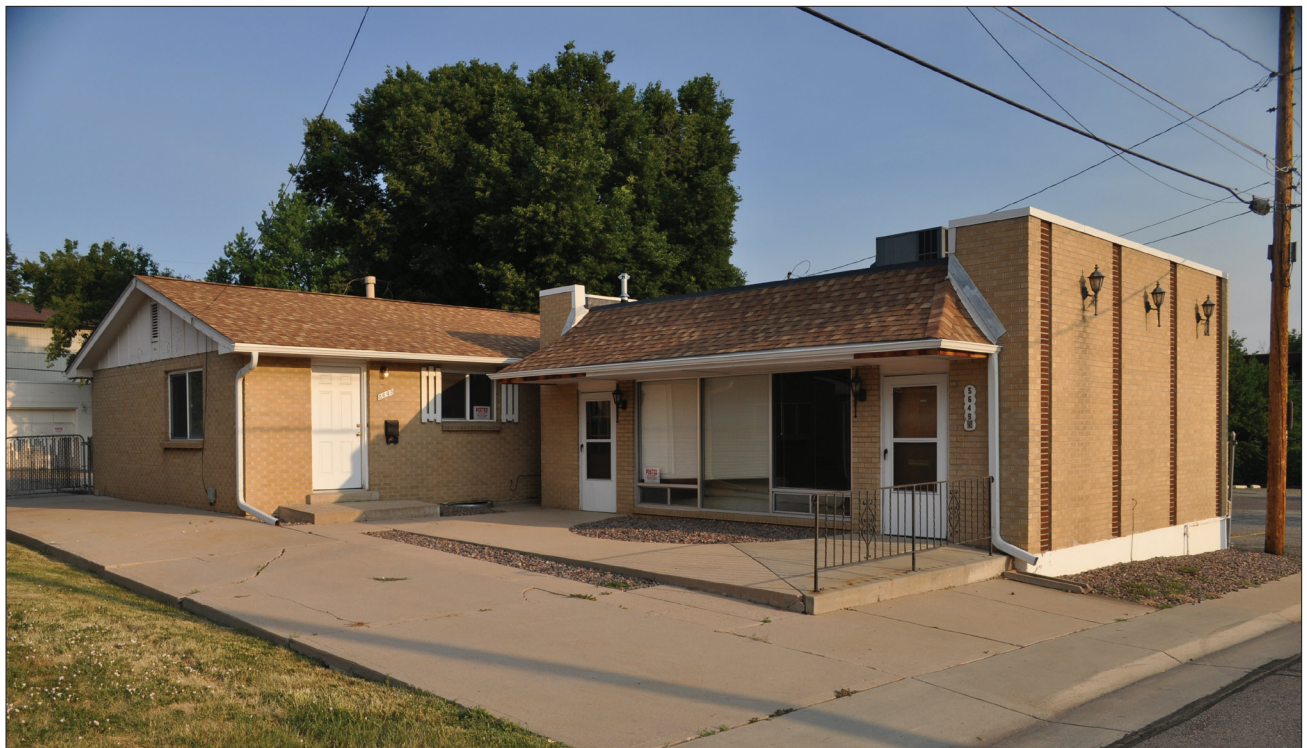
The former Tammy G's Beauty Bazaar is sited to the east of a rectangular lot facing S Delaware St.

The Beauty Bazaar is one-story building with an L-shaped footprint formed by a house and a commercial addition.

The south elevation/facade of the commercial addition is symmetrical, with two doors flanking a bay of three full-height vertical windows above a rowlock sill.

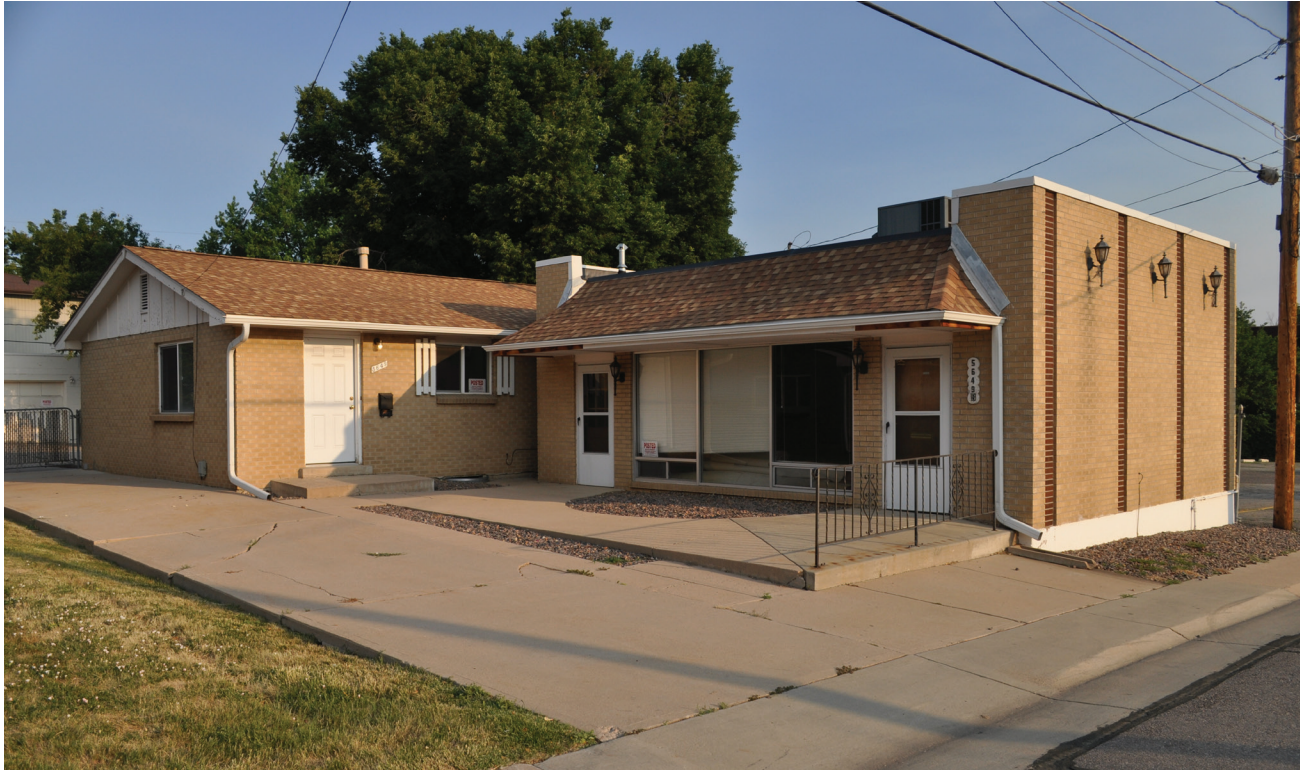
The east, west and north walls rise above the mansard-style fascia to form tall parapet walls. The east wall displays a decorative pattern of four full-height vertical rows of stack-bond red brick, recessed just behind the yellow brick of the walls. Centered between them, and adjacent to the two doors on the south wall, are metal and glass wall sconces in an old-fashioned coach lamp design.

Photo: 5649 SDeS 01.jpg
South Wall, Facade (left); East Wall (right), S Delaware St in foreground.

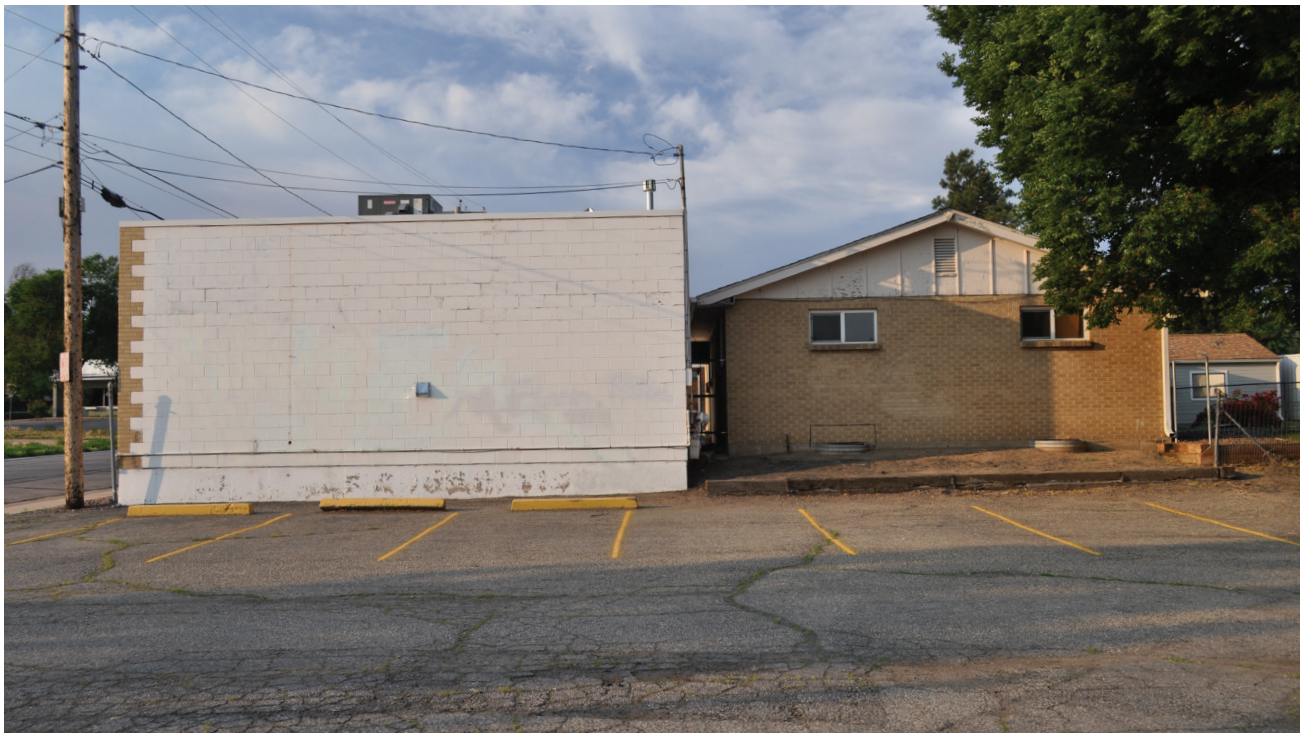
The facade of the commercial addition is perpendicular to that of the house, creating a shared front entry court to the southeast. The simple house appears completely unattached to the commercial building, which is positioned parallel to its facade and extends just beyond its north wall. The similarity and quality of the brick and the high standard of workmanship on the two buildings is commensurate, indicating that they were probably built at around the same time.

The north elevation of the commercial addition is blind running-bond concrete block masonry. The concrete foundation varies in height as the lot slopes down to the north.

Photo: 5649 SDeS 02.jpg
North Wall of commercial building (left) and house (right), showing the opening between the two buildings.
