COLORADO CULTURAL RESOURCE SURVEY

Architectural Inventory Form

1. Resource number: 5AH.1964
2. Temporary resource #: N/A
3. County: Arapahoe
4. City: Littleton
5. Historic building name: Littleton Professional Building
6. Current building name: Littleton Professional Building
7. Building address: 709 W Littleton Blvd
8. Owner name, address: Bam Property Management 2 LLC
2021 S Humbolt St
Denver, CO 80210-3337

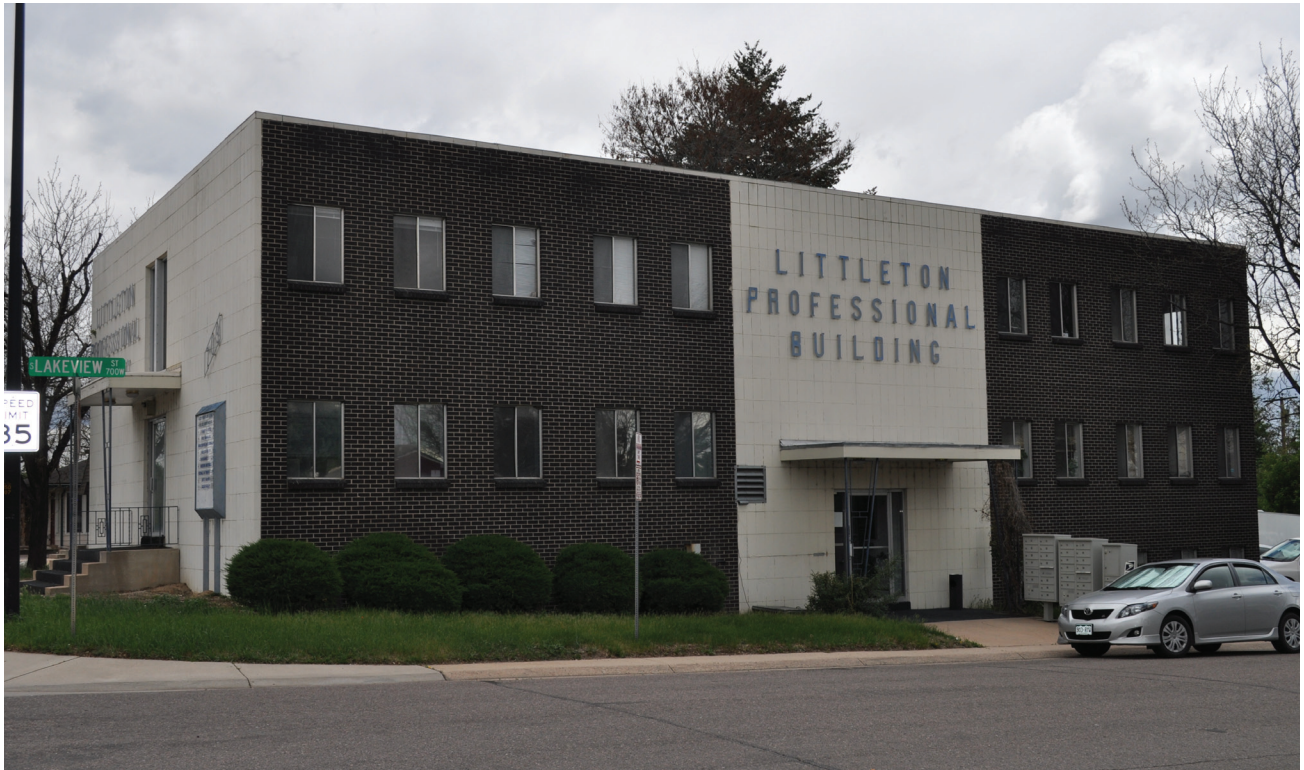
Photo: 709 WLB 01.jpg

South Wall (left); East Wall (right), S Lakeview St in foreground.

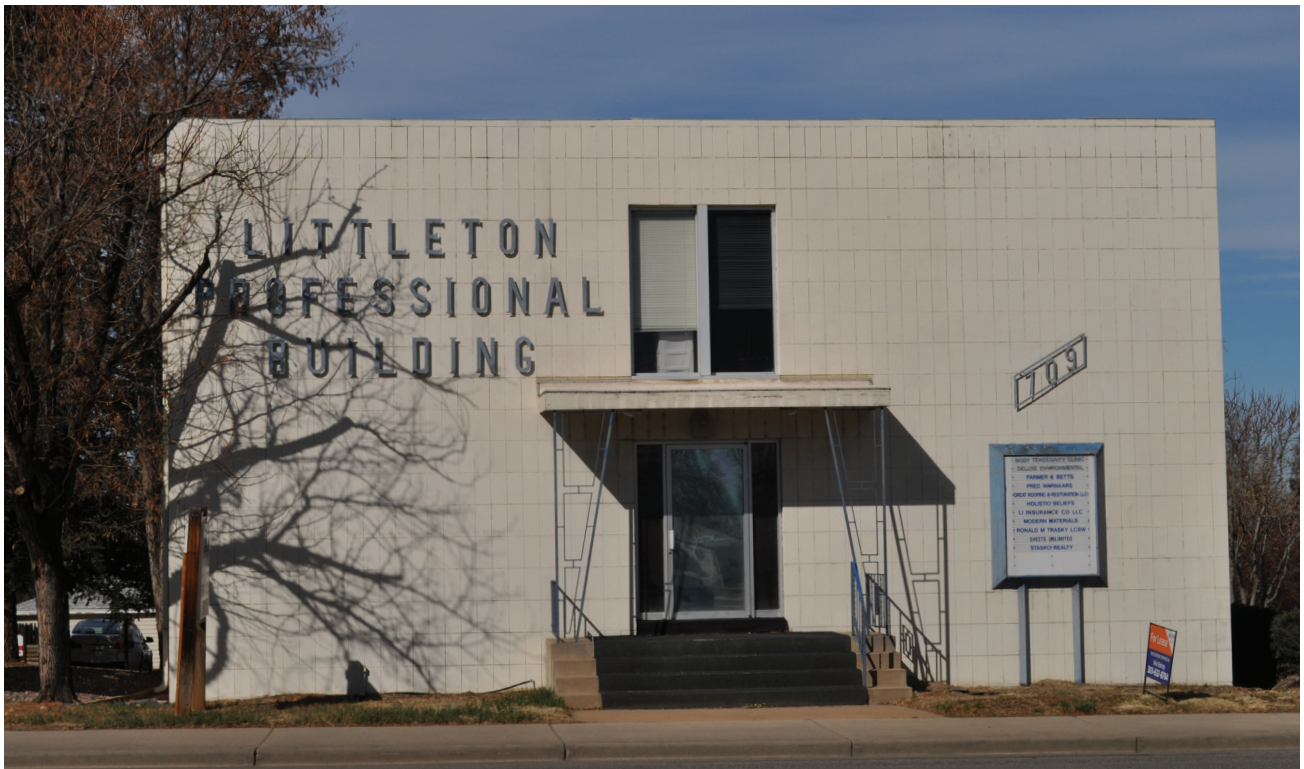
Photo: 709 WLB 02.jpg

The south wall is clad with vertical stack-bond tile. A single glass and metal entry door with two narrow glass sidelights appears above a concrete stair. A flat canopy supported by decorative V-shape metal columns shelters the landing. A low, decorative railing runs between the metal columns and the wall. Above the canopy, at the second story, is a pair of recessed vertical windows.

South Wall, W Littleton Blvd in foreground.

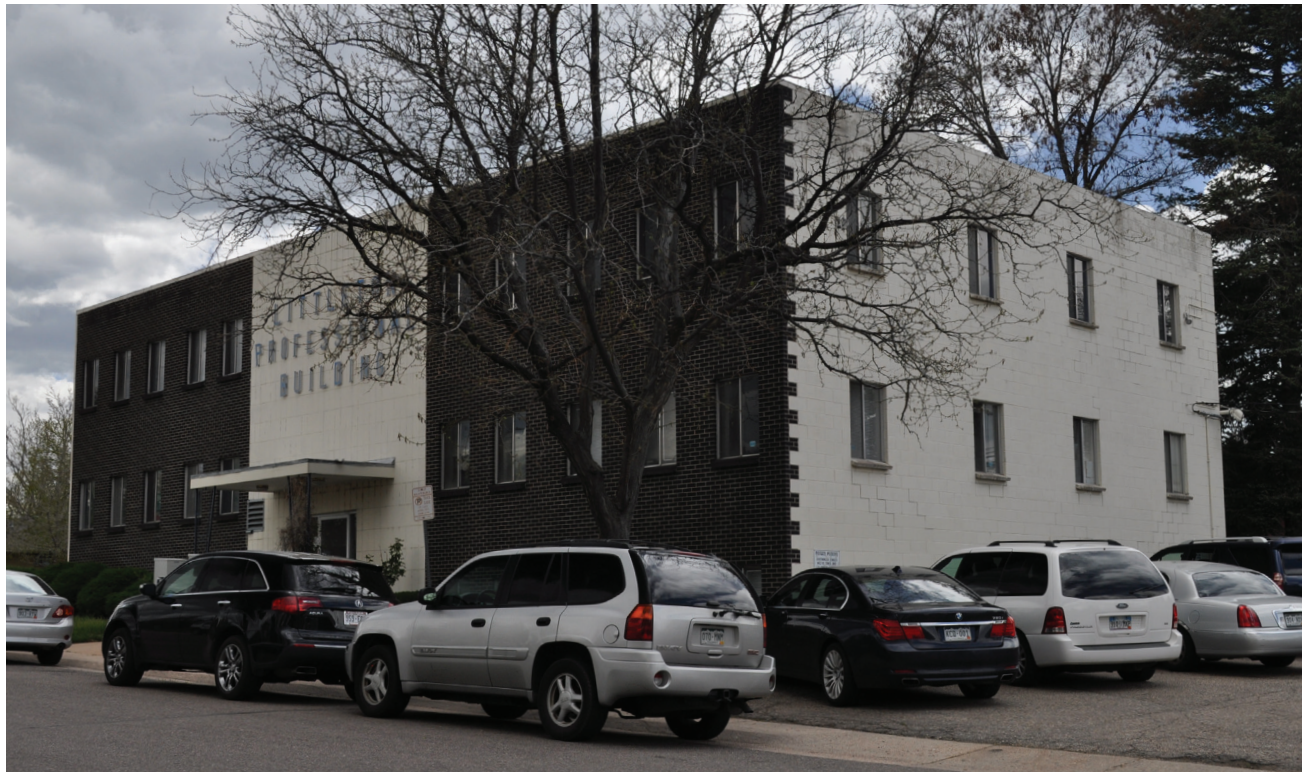
The east wall is largely brick masonry. A second entry appears in a central panel of vertical stack-bond tile. This east entry also has a single glass and metal door, narrow glass sidelights, and a flat canopy with decorative V-shape columns. It is level with a walkway from the public sidewalk. A series of flush windows with rowlock sills appear at the first and second stories of the brick masonry.

The west and north walls are running bond concrete block masonry with rows of windows with angled block sills at the first and second floors. The lower level windows, largely below grade and sometimes within window wells, increase in height as the lot slopes downward to the north.

Photo: 709 WLB 03.jpg
East Wall (left); North Wall (right), S Lakeview St in foreground.
