National Register of Historic Places Registration Form

Historic name: Littleton Post Office

Street & number: 5753 S. Prince St.

City or town: Littleton State: CO County: Arapahoe

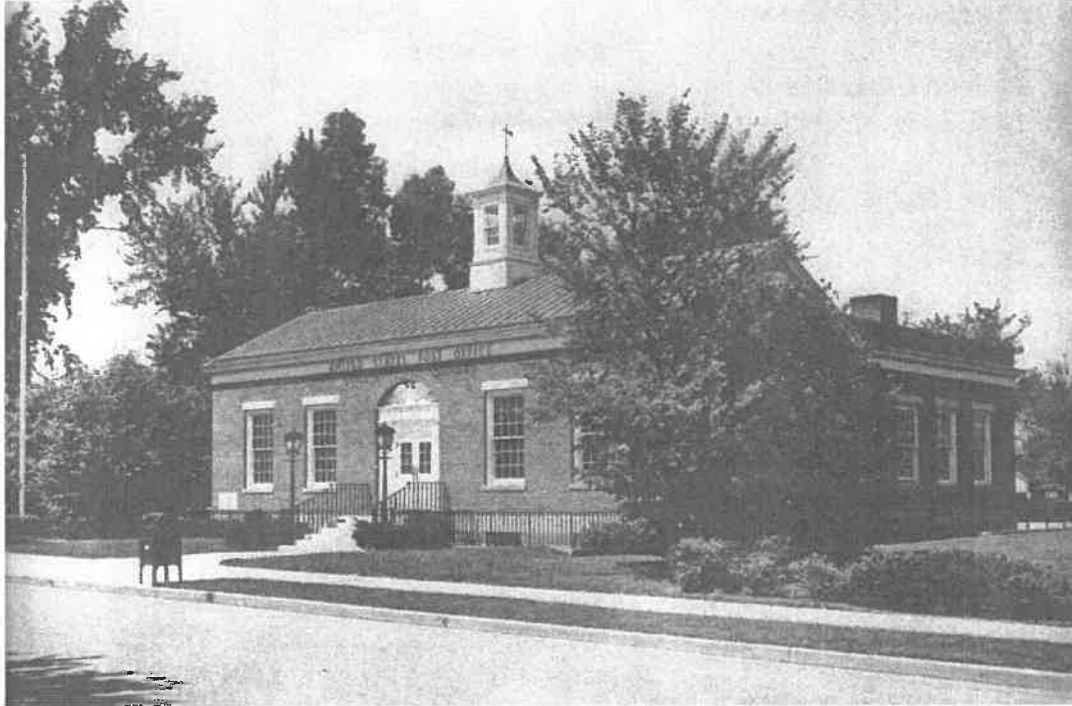
HP1 Littleton Post Office. East and north sides. Historic photo ca. 1948. View to southwest. *Photo Source – Grissinger, Littleton Independent 60th Anniversary Edition 1888-1948; Photo Courtesy of Littleton Museum*

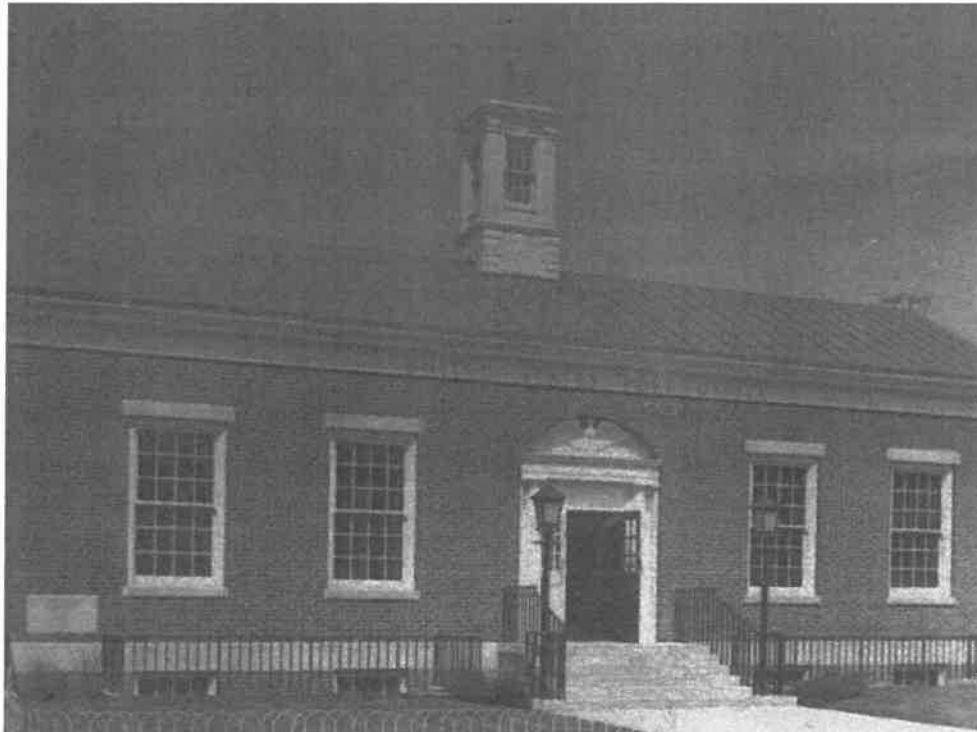
HP2 Littleton Post Office. East side. Historic photo ca 1940-1950. View to west. *Photo Courtesy of Littleton Museum*

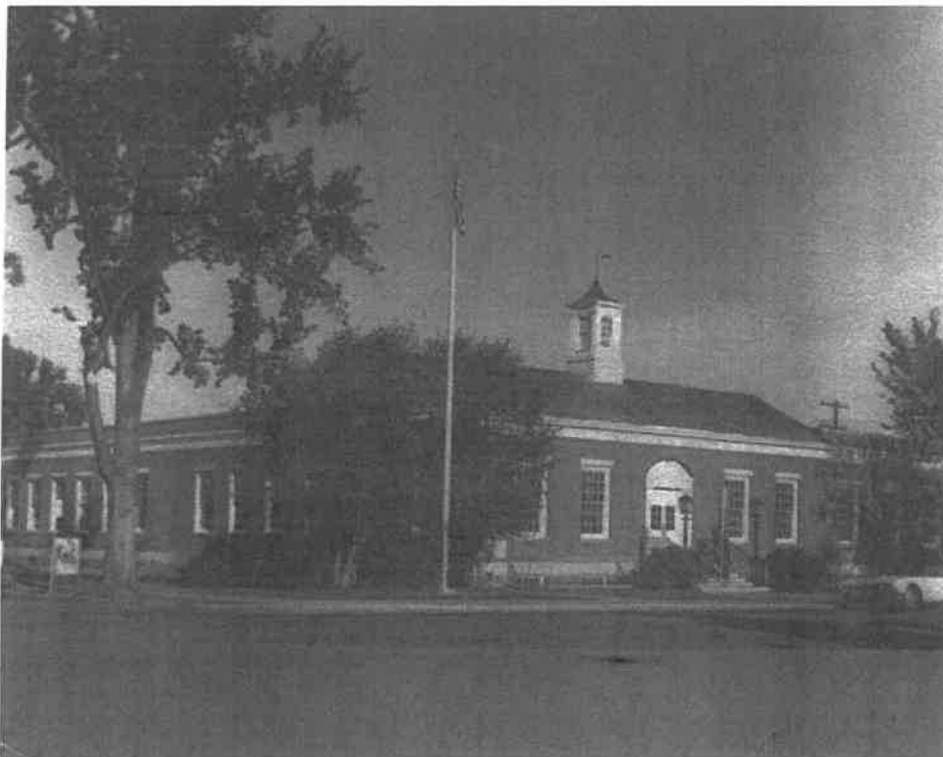
HP3 South and east sides. Historic photo ca 1962. View to northwest. *Photo Courtesy of Littleton Museum*

The 1962 "L" addition to the north and west of the original building is 47' wide x 120' deep and recessed 1'-6" back from the original wall. The addition closely matches the materials of the original building, using a slightly lighter color modular red-brown brick laid in common bond with cast stone water table. It has a flat roof with a brick parapet above the cast stone cornice. The cast stone cornice replicates the 1939 wood cornice in size and shape, but without the dentils. The four northern windows are symmetrically spaced and match the original windows in style and size. There is one scupper draining the roof to the east. The southern-most window was modified to accommodate an accessible entrance with a concrete ramp, which also matches the building in style, materials, and detailing. The ramp, which turns north along the façade, then east out to Prince Street, was installed ca. 2003. The window was sensitively modified into a single width, twelve-light wood door, with an eight-light frosted transom window, and full height six-light sidelight. The entrance is protected by a similar metal-framed canvas awning as found at the main entrance and also installed ca. 2003.

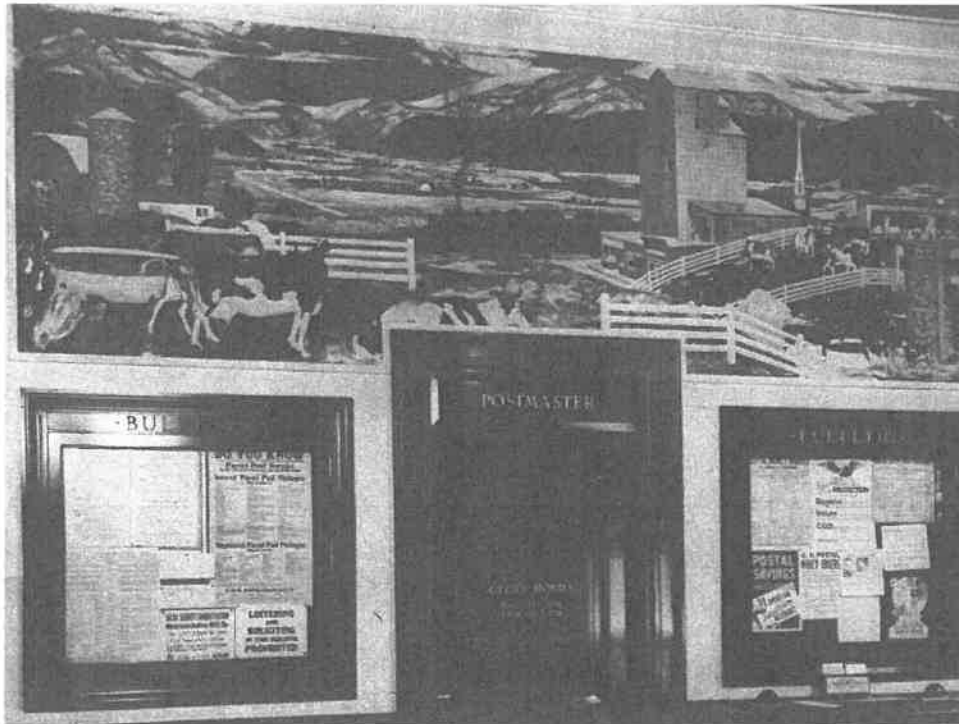
HP4 Littleton Post Office interior showing mural. Historic photo ca 1948. *Photo Source – Grissinger, Littleton Independent 60th Anniversary Edition 1888-1948; Photo Courtesy of Littleton Museum*

In 1939, a 13' x 4'-6" mural titled "Littleton, Colorado," by Pennsylvania-based WPA artist John Fraser, was mounted above Postmaster Willard A. Teller's office door in the lobby area of the new Post Office. Fraser worked from photographs he saw in the local newspaper, the *Littleton Independent*. Conveying the essence of an agricultural town, Fraser's mural is a composite with farms, cows, trains, mountains, and the Columbine Mill. Fraser's mural was selected in a nationwide competition as the mural for Colorado (each state received one mural) and Colorado's selection went to Littleton, since it was the subject of the mural. Mr. Fraser personally transported the completed canvas via train from Pittsburgh to Littleton. It was rated by the *New York Times* as one of the twelve best among murals that were done by a WPA artist for a city in each of the 48 states, and it was featured in *Life* magazine. The mural was removed at an unknown date some years later and discovered in the 1970s by Littleton Museum Director Robert McQuarie, who said it had been "rolled up like wallpaper and dropped in a corner," according to a 1985 *Littleton Independent* story by Dave Zalubowski. It took more than fifteen years to find enough money to pay for conservation services for the painting, which now hangs, restored and handsomely-framed, in the Littleton City Council Chambers.

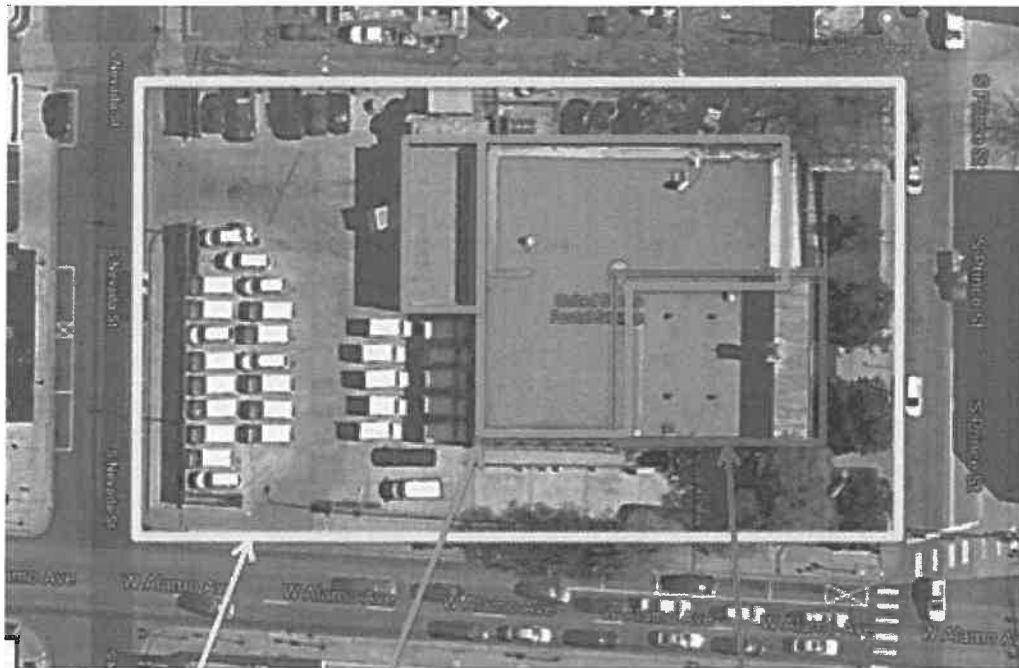
Property
Boundary

1962 Addition to the
Littleton Post Office
