HISTORIC BUILDING INVENTORY RECORD

PROJECT NAME: Littleton Historic Buildings Survey 1997 (#97-01-082)		COUNTY: Arapahoe	CITY: Littleton	STATE ID NO.: 5AH1225
		TEMPORARY NO.: 2077-17-4-03-012		
CURRENT BUILDING NAME:		OWNER: RICHARDSON, JOHN N 1/3 INT 3890 E KETTLE AVE LITTLETON CO 80122		
ADDRESS: 5609 S CURTICE ST Littleton, CO 80120		TOWNSHIP 5S RANGE 68W SECTION 17 NE 1/4 SE 1/4		
HISTORIC NAME: Finn/Scott Residence		U.S.G.S. QUAD NAME: Littleton, Colo. YEAR: 1965 (r. 1994) X 7.5' 15'		
DISTRICT NAME:		BLOCK: 1 LOT(S): 12 ADDITION: LITTLETON ORIG. TOWN YR. OF ADDITION: 1872		
FILM ROLL NO.: 97-13 BY: Roger Whitacre	NEGATIVE NO.: 10	LOCATION OF NEGATIVES: Littleton Hist. Mus.	DATE OF CONSTRUCTION: ESTIMATE: ACTUAL: 1900 SOURCE: Arapahoe County Assessor

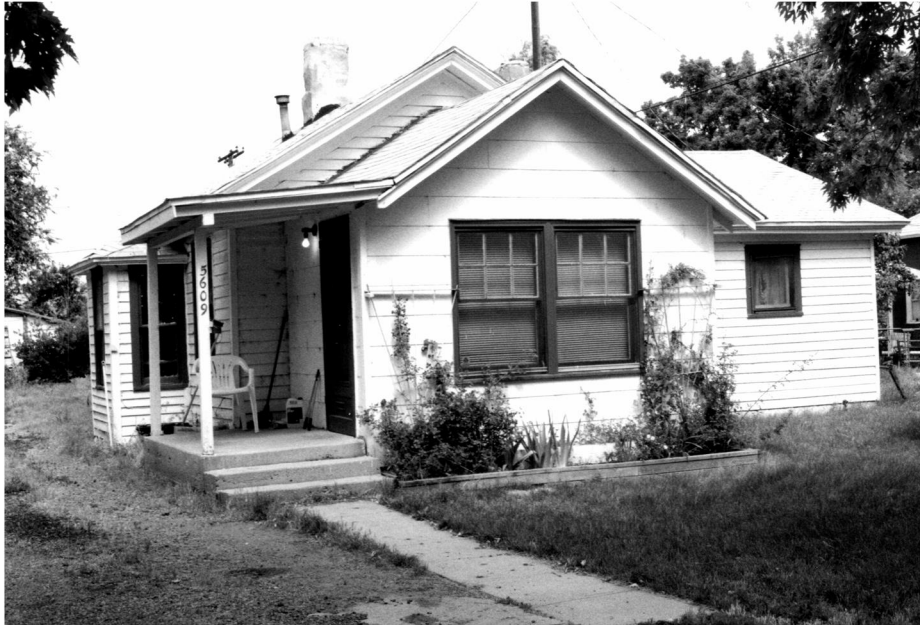
USE: PRESENT: Residence HISTORIC: Residence	
			CONDITION: EXCELLENT X GOOD FAIR DETERIORATING	
			EXTENT OF ALTERATIONS: MINOR MODERATE X MAJOR DESCRIBE: Addition on north; some nonoriginal siding; stucco on chimney; porch enclosed and porch added and one removed.

CONTINUED YES X NO	
STYLE: No Style		STORIES: 1	ORIGINAL SITE X MOVED DATE(S) OF MOVE:	
MATERIALS: Wood, Concrete		SQ. FOOTAGE: 844	NATIONAL REGISTER ELIGIBILITY	
ARCHITECTURAL DESCRIPTION: One-story double front gable roof frame dwelling with gabled projection to north; overhanging eaves; exposed rafters; center, stuccoed chimney. Walls clad with lap siding except for projecting front gable which has wide shingle siding. Paired, 6/1-light double-hung sash windows with shared wood surround on front gable. Door perpendicular to porch which has shed roof with post supports atop concrete deck and is on south side of house. Hipped roof bay window on south has lap siding and 1/1-light double-hung sash windows. Shingled garage and shed. CONTINUED? YES X NO			INDIVIDUAL: YES X NO	
			CONTRIBUTING TO DISTRICT: YES NO	
			LOCAL LANDMARK DESIGNATION: No NAME: DATE:	
			ASSOCIATED BUILDINGS? X YES NO TYPE: Garage & Shed IF INVENTORIED, LIST ID NOS.:
