HISTORIC BUILDING INVENTORY RECORD

PROJECT NAME: Littleton Historic Buildings Survey 1997 (#97-01-082)		COUNTY: Arapahoe	CITY: Littleton	STATE ID NO.: 5AH1333
		TEMPORARY NO.: 2077-17-4-16-005		
CURRENT BUILDING NAME:		OWNER: CISSELL, VINCENT J & SHAARON K JT TEN 5872 S NEVADA ST LITTLETON CO 80120		
ADDRESS: 5872 S NEVADA ST Littleton, CO 80120		TOWNSHIP 5S	RANGE 68W	SECTION 17 SE 1/4 SE 1/4
HISTORIC NAME: May/Schott Residence		U.S.G.S. QUAD NAME: Littleton, Colo. YEAR: 1965 (r. 1994) X 7.5' 15'		
DISTRICT NAME:		BLOCK: 14	LOT(S): 15-16	
		ADDITION: PEABODY'S RESUB		YR. OF ADDITION: 1887
FILM ROLL NO.: 97- 1 BY: Roger Whitacre	NEGATIVE NO.: 36	LOCATION OF NEGATIVES: Littleton Hist. Mus.		DATE OF CONSTRUCTION: ESTIMATE: 1910 ACTUAL: SOURCE: Water Supply Map, 1912

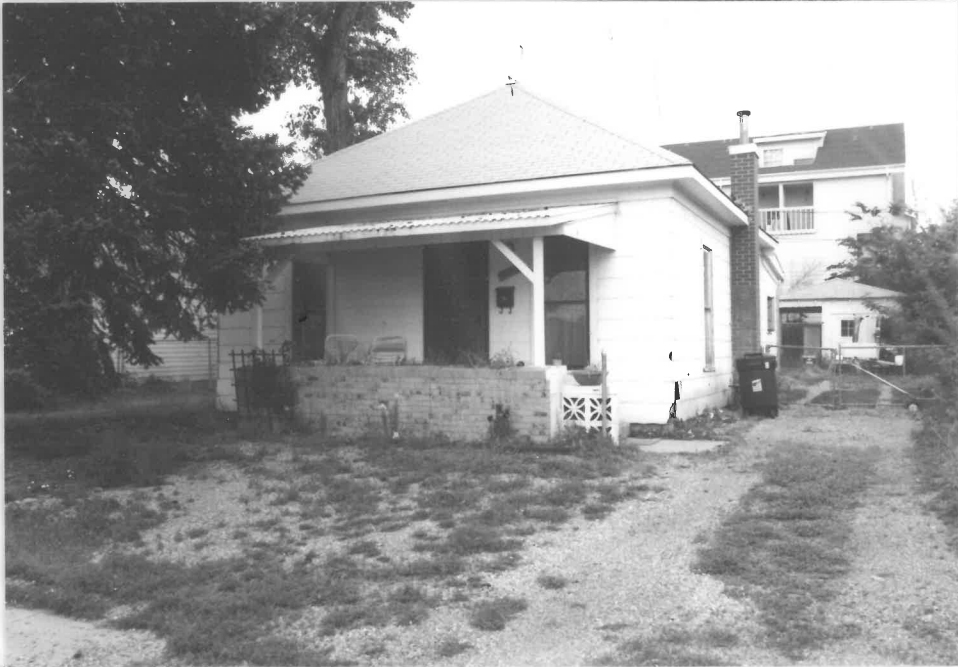
USE: PRESENT: Residence HISTORIC: Residence
				CONDITION: EXCELLENT GOOD X FAIR DETERIORATING
				EXTENT OF ALTERATIONS: MINOR X MODERATE MAJOR DESCRIBE: Asbestos shingles; porch alterations; new chimney.

CONTINUED YES X NO
STYLE: No Style		STORIES: 1	ORIGINAL SITE X MOVED DATE(S) OF MOVE:	
MATERIALS: Wood, Concrete, Asbestos Shingles		SQ. FOOTAGE: 864	NATIONAL REGISTER ELIGIBILITY	
ARCHITECTURAL DESCRIPTION: One-story pyramidal hipped roof frame dwelling with overhanging eaves; plain fascia board. Full-height brick chimney on south with metal top. Walls clad with asbestos shingles; concrete foundation. Shed roof porch with post supports has corrugated roof; concrete deck; solid brick balustrade. Slightly off-center door. 1/1-light double-hung sash windows with thick wood surrounds.		INDIVIDUAL: YES X NO		
		CONTRIBUTING TO DISTRICT: YES NO		
		LOCAL LANDMARK DESIGNATION: No		
		NAME: DATE:		
		ASSOCIATED BUILDINGS? X YES NO TYPE: Garage		
		IF INVENTORIED, LIST ID NOS.:		
		CONTINUED? YES X NO		
ADDITIONAL PAGES: YES X NO
