HISTORIC BUILDING INVENTORY RECORD

PROJECT NAME: Littleton Historic Buildings Survey 1997 (#97-01-082)		COUNTY: Arapahoe	CITY: Littleton	STATE ID NO.: 5AH1296
CURRENT BUILDING NAME: Merle's Alignment Service		OWNER: BELL, DOYLE F & SHARON K JT TEN 2609 W MAIN ST LITTLETON CO 80120		
ADDRESS: 2609 W MAIN ST Littleton, CO 80120		TOWNSHIP 5S RANGE 68W SECTION 17 NE 1/4 SE 1/4		
HISTORIC NAME: Skelly Service Station		U.S.G.S. QUAD NAME: Littleton, Colo. YEAR: 1965 (r. 1994) X 7.5' 15'		
DISTRICT NAME:		BLOCK: 1 LOT(S): 20-21 P ADDITION: LITTLETON ORIG. TOWN YR. OF ADDITION: 1872		
FILM ROLL NO.: 97- 7 BY: Roger Whitacre	NEGATIVE NO.: 26	LOCATION OF NEGATIVES: Littleton Hist. Mus.	DATE OF CONSTRUCTION: ESTIMATE: 1930s ACTUAL: SOURCE: Sanborn Map & Directory

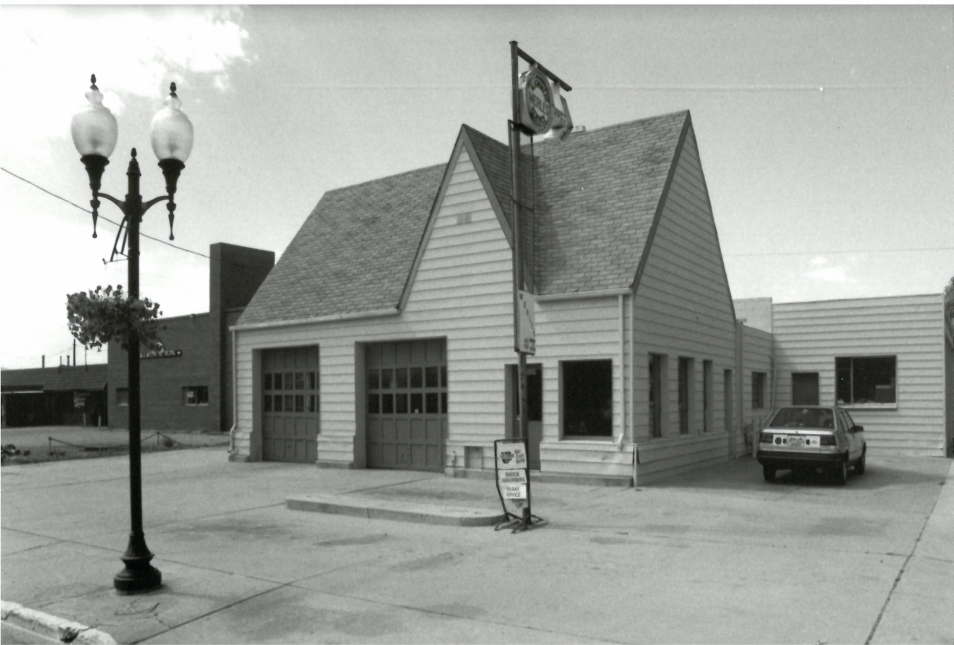
USE: PRESENT: Auto Service Station HISTORIC: Auto Service Station	
			CONDITION: EXCELLENT X GOOD FAIR DETERIORATING	
			EXTENT OF ALTERATIONS: MINOR X MODERATE MAJOR DESCRIBE: Nonhistoric siding; rear addition.

CONTINUED YES X NO	
STYLE: English/Norman Cottage		STORIES: 1	ORIGINAL SITE X MOVED DATE(S) OF MOVE:	
MATERIALS: Wood, Concrete, Stucco		SQ. FOOTAGE: 1026	NATIONAL REGISTER ELIGIBILITY	
<p>ARCHITECTURAL DESCRIPTION: One-story, steeply pitched cross-gable roofed gas station; composition roofing; flush eaves. Walls clad with wide lap siding which extends to eaves; small vent in front gable. Brick water table; concrete foundation projects outward along edge of building. South wall has two paneled and glazed overhead garage doors toward west and a pedestrian door and plate glass window toward east. Large multi-light windows on west and east walls. Stucco and half-timbering (original) on north wall. Gas pump island (minus pumps) and pole topped by sign in front of building on south. Rear addition is rectangular, flat roofed, concrete block building with tripartite metal frame windows on west and garage doors on east.</p>			INDIVIDUAL: YES X NO
