HISTORIC BUILDING INVENTORY RECORD

PROJECT NAME: Littleton Historic Buildings Survey 1997 (#97-01-082)		COUNTY: Arapahoe	CITY: Littleton	STATE ID NO.: 5AH1299
		TEMPORARY NO.: 2077-17-4-08-008		
CURRENT BUILDING NAME:		OWNER: STONEBRIDGE DEVELOPMENT GROUP INC 2646 W MAIN ST LITTLETON CO 80120		
ADDRESS: 2646 W MAIN ST Littleton, CO 80120		TOWNSHIP 5S RANGE 68W SECTION 17 NE 1/4 SE 1/4		
HISTORIC NAME: Bill's Cafe		U.S.G.S. QUAD NAME: Littleton, Colo. YEAR: 1965 (r. 1994) X 7.5' 15'		
DISTRICT NAME:		BLOCK: 2 LOT(S): 9 P ADDITION: LITTLETON ORIG. TOWN YR. OF ADDITION: 1872		
FILM ROLL NO.: 97- 8 BY: Roger Whitacre	NEGATIVE NO.: 12	LOCATION OF NEGATIVES: Littleton Hist. Mus.	DATE OF CONSTRUCTION: ESTIMATE: 1920s ACTUAL: SOURCE: Sanborn Maps

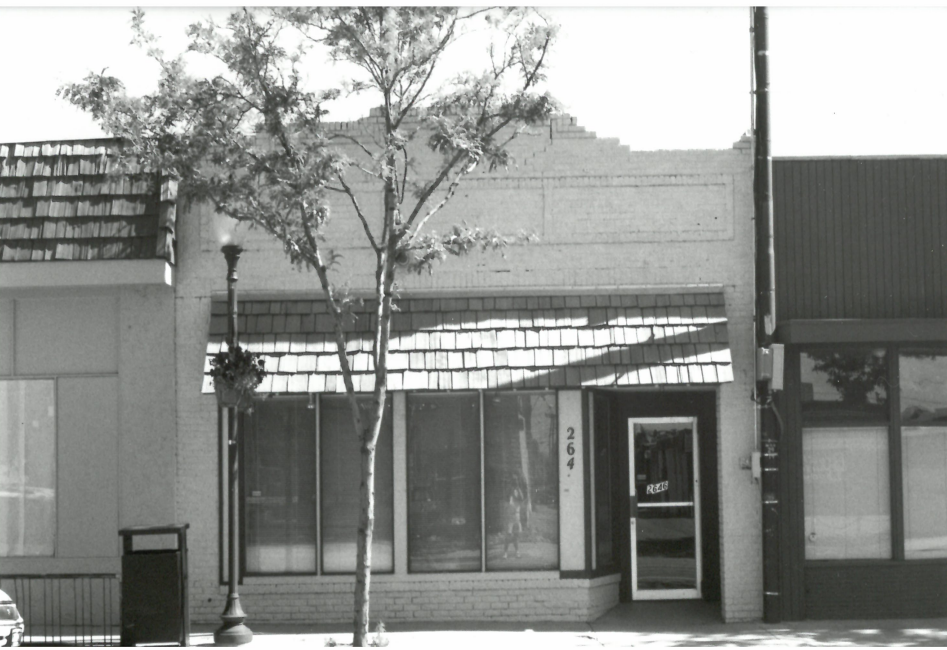
USE: PRESENT: Commercial	
			HISTORIC: Commercial	
			CONDITION: EXCELLENT GOOD X FAIR DETERIORATING	
			EXTENT OF ALTERATIONS: MINOR X MODERATE MAJOR DESCRIBE: Painted brick; shingled hood; new windows with new brick underneath; newer door. CONTINUED YES X NO

STYLE: No Style		STORIES: 1	ORIGINAL SITE X MOVED DATE(S) OF MOVE:	
MATERIALS: Brick, Wood		SQ. FOOTAGE: 1620	NATIONAL REGISTER ELIGIBILITY	
ARCHITECTURAL DESCRIPTION: One-story brick commercial building with flat roof with shaped parapet, part of which is missing. Walls composed of painted, wire-drawn brick; paneling above storefront. Shed roof, shingled hood above windows and door. Inset entrance with metal frame glazed door. Two sets of paired plate glass windows; painted brick under windows. CONTINUED? YES X NO			INDIVIDUAL: YES X NO	
			CONTRIBUTING TO DISTRICT: YES NO	
			LOCAL LANDMARK DESIGNATION: No NAME: DATE:	
			ASSOCIATED BUILDINGS? YES X NO TYPE:	
IF INVENTORIED, LIST ID NOS.:				
ADDITIONAL PAGES: YES X NO
